# **Table of Contents**

Statements of Significance and Municipal Heritage Survey Review Forms

The following are the Statements of Significance for each site along with its corresponding Municipal Heritage Survey Review Form

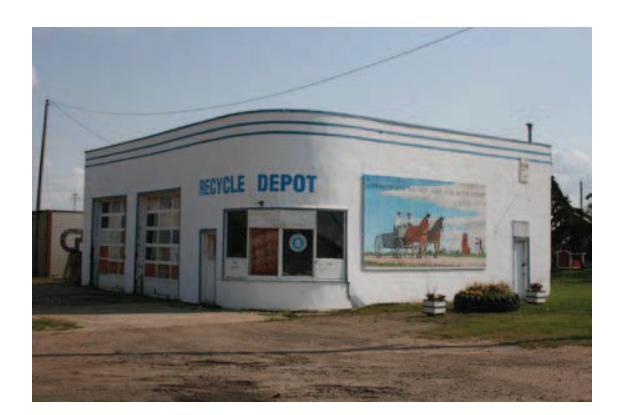
#### **Recycle Depot**

The 1950 one-storey Recycle Depot is a commercial garage with a square parapet, a smooth stucco finish, and a rounded corner with "RECYCLE DEPOT" painted in blue above a curved window. It is located just south of and adjacent to the railroad tracks, on Main Street (50<sup>th</sup> Street) in the Village of Holden.

- The flat roof
- The square parapet
- The smooth stucco finish
- The curved north west corner with a curved window
- The two garage doors on the north façade

- The concrete foundation
- The pattern, style and construction of all original windows and doors, and window and door openings

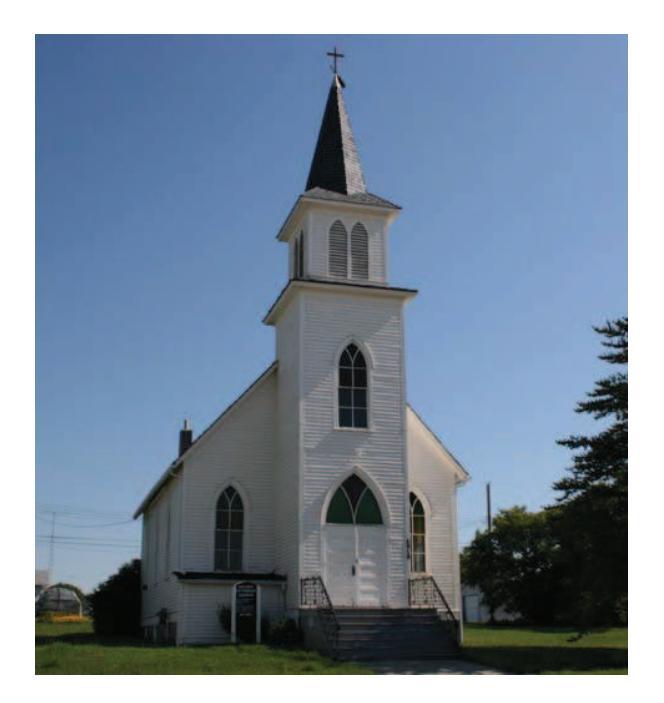
#### **Holden Lutheran Church**

The 1915 Holden Lutheran Church is a one-storey church with a front-facing gable roof, white clapboard siding, an apse, and tripartite tower with a square base and belfry, and octagonal steeple topped by a Roman cross and a weathervane. The church is located just off Main Street, on a residential avenue in the Village of Holden.

- The steeply pitched front-facing gable roof with wood shingles and exposed rafters beneath the eaves
- The clapboard siding with corner boards
- The five-sided apse with two pointed arch windows
- The tripartite tower (base, belfry and steeple) with pointed arch windows and double doors
- The square belfry
- The octagonal steeple topped by a Roman cross and weathervane with '1915' in the tail
- The pattern, style and construction of all original windows and doors, including all pointed arch and coloured glass windows

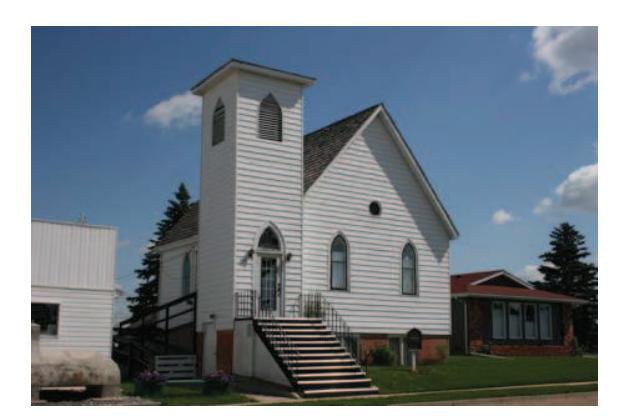
**Holden United Church**

The 1910/1911 Holden United Church is a one-storey church with a full basement, a front-facing gable roof with a central quatrefoil coloured glass round window in the gable end, vinyl siding, an offset tower with a flat top on the left of the front façade, and a brick foundation. The church is located just off Main Street ( $50^{th}$  Street) in the village of Holden.

- The front-facing gable roof with wood shingles
- The round window in the gable end with a quatrefoil coloured glass
- The offset tower with a flat roof on the exterior left of the front façade
- The main entrance in the tower with one door and a pointed arch transom
- The brick foundation
- The pattern, style and construction of all original windows and doors, including all pointed arch and coloured glass windows

Integrity Criteria:	The overall integrity of this building is satisfactory, except for the vinyl siding.
1. Location	The location of the building has not changed.

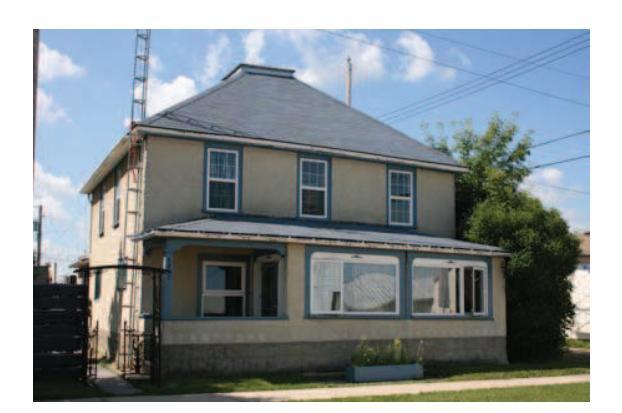
#### **Mumford Residence**

The 1907 Mumford Residence is a two-storey house with a hipped roof and flat top, a bottle glass stucco finish, and a partially enclosed verandah with a hipped roof. It is located on  $50^{\text{th}}$  Avenue across from the Holden Museum, just off Main Street ( $50^{\text{th}}$  Street) in the Village of Holden.

4. Materials	The authentic materials of the building have not changed, except for the application of a bottle glass stucco finish and the sympathetic replacement of the original windows and doors.

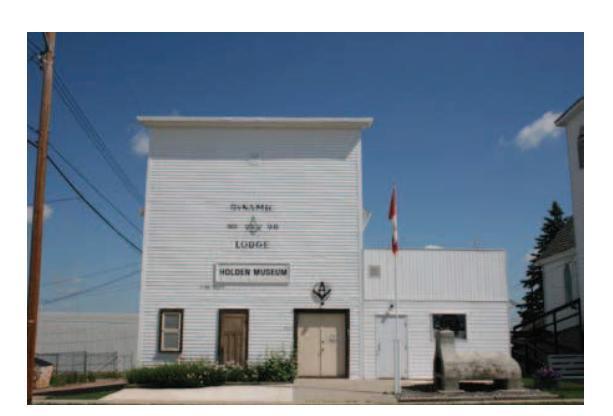
#### **Holden Museum**

The 1911 Holden Museum is a large rectangular two-storey hall and has white clapboard siding with corner boards, and "DYNAMIC NO. 96 LODGE" painted in black around the Masonic Square and Compasses symbol with a G. It is located on 50<sup>th</sup> Avenue in the village of Holden, near the Holden Cenotaph.

- The front-facing gable roof
- The clapboard siding with corner boards
- The rectangular Boomtown front with a shelf overhang
- The black painted sign reading "DYNAMIC NO. 96 LODGE" around the Masonic Square and Compasses with a G
- The black painted sign reading "FIRE DEPT." below and to the left of the painted sign reading "DYNAMIC NO. 96 LODGE"
- The double door opening on the front façade
- The concrete foundation
- The pattern, style and construction of all original windows and doors

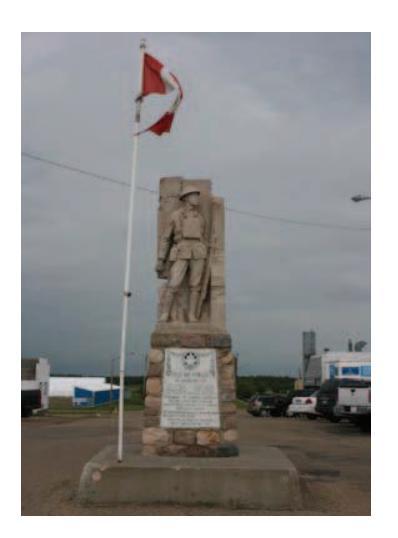
### **Holden Cenotaph**

The 1923 Holden Cenotaph is a military memorial depicting a First World War soldier looking east with his body facing south toward the train station. On the river rock base of the cenotaph there is a marble plaque bearing the names of those who died in the war from 1914 to 1919 on the south façade, and a metal plaque bearing the names of those who died from 1939 until 1945 on the east façade. The Holden Cenotaph is located in the centre of the junction of Main Street (50<sup>th</sup> Street) and 50<sup>th</sup> Avenue.

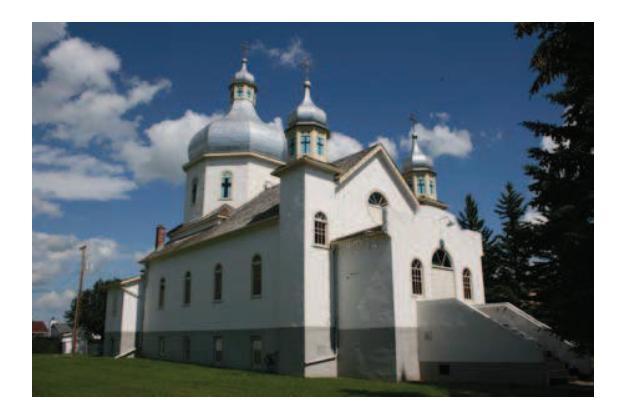
## 5220 50<sup>th</sup> Avenue Descent of the Holy Spirit Ukrainian Catholic Church

The 1944 Descent of the Holy Spirit Ukrainian Catholic Church is a one-storey church with a front-facing gable roof, a smooth white stucco finish, a large silver-coloured onion dome at the rear of the church and two domed towers at the front corners of the church. It is located on  $50^{\text{th}}$  Avenue in a residential part of the village of Holden.

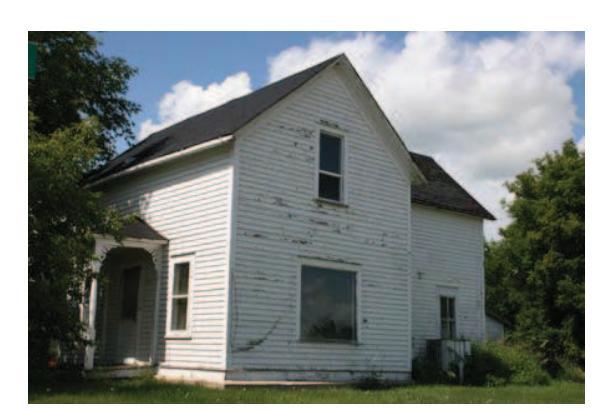
#### **Christianson Residence**

The circa 1916 one and one-half storey Christianson Residence has a side-facing gable roof, whitewashed clapboard siding with corner boards, a rear wing with an intersecting gable roof, and a front porch with a hipped roof, turned spindle posts and gingerbread trim. It is located across from the school on a residential avenue in the village of Holden.

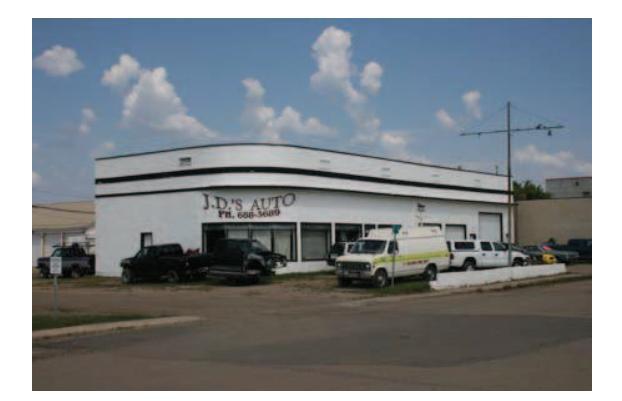
The 1948 J.D.'s Auto is a one-storey commercial building with a rectangular parapet and barrel roof, smooth white stucco siding, and a curved corner with "J.D.'S AUTO PH. 688-3689" painted above the curved window. It is located on Main Street in the village of Holden, just north of the railroad tracks.

- The barrel roof and rectangular parapet
- The smooth stucco finish
- The curved south east corner with a curved window
- The overhanging ledge half-ways between the roofline and the windows
- The concrete foundation
- The pattern, style and construction of all original windows and doors, and window and door openings
## J.D.'s Auto

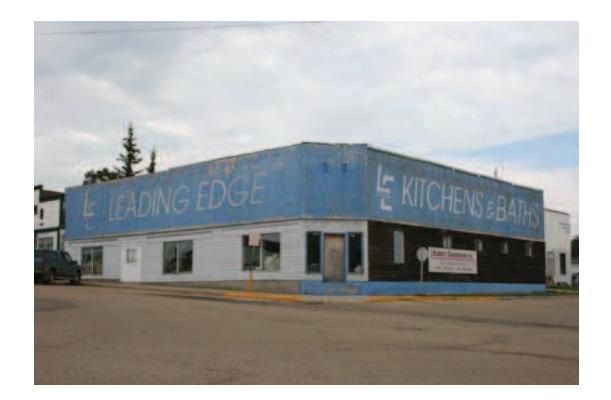
Leading Edge Kitchen and Baths

The 1946, large, one-storey commercial building with a flat roof and shiplap wood siding with corner boards, a chamfered entrance, and a large, slightly overhanging parapet with a stucco finish and a painted sign that reads, "LEADING EDGE KITCHENS AND BATHS" across two façades. It is situated in a prominent location on Main Street in Holden.

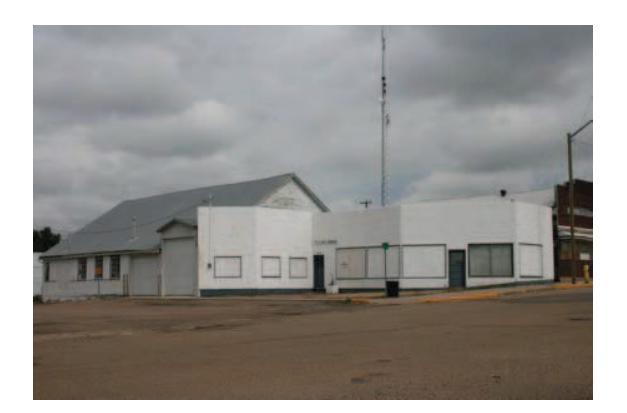
## Village Garage

The 1926/1941 Village Garage is a one-storey commercial building with a front-facing gable roof, whitewashed shiplap siding, and a large, irregular addition with a flat roof, parapet and stucco finish on the front façade. It is located on a corner lot on Main Street ( $50^{th}$  Street) in the village of Holden.

- The front-facing gable roof with exposed rafters beneath the eaves
- The shiplap siding with corner boards
- The windows with multiple panes and plain, flat wood surrounds
- The original wood double garage doors at the rear of the building
- The concrete foundation
- The front addition with an irregular footprint
- The smooth stucco finish on the addition
- The rectangular parapet on the addition
- The wood doors with three panels and a glass window
- The pattern, style and construction of all original window and door openings

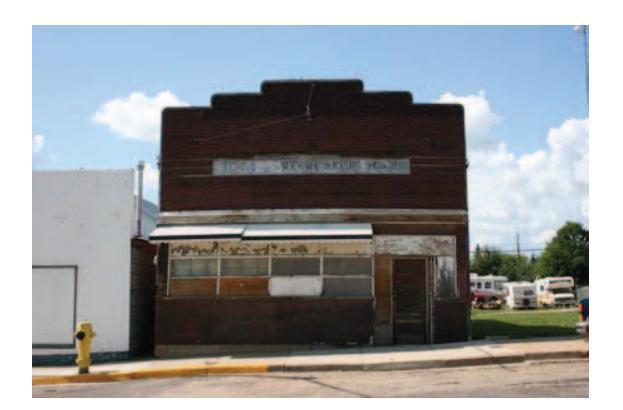
The 1909/1942 John's Snooker Room is a one-storey commercial building with a stepped parapet, shiplap siding on the side façades, asphalt roll siding on the front façade, and a bank of horizontal windows beneath a metal awning on the front façade. It is located on Main Street (50<sup>th</sup> Street), in the village of Holden.

- The side-facing gable roof
- The stepped parapet
- The shiplap siding
- The corbelled wooden ribbon above the windows on the front façade
- The wooden signboard
- The concrete foundation
- The pattern, style and construction of all original window and door openings

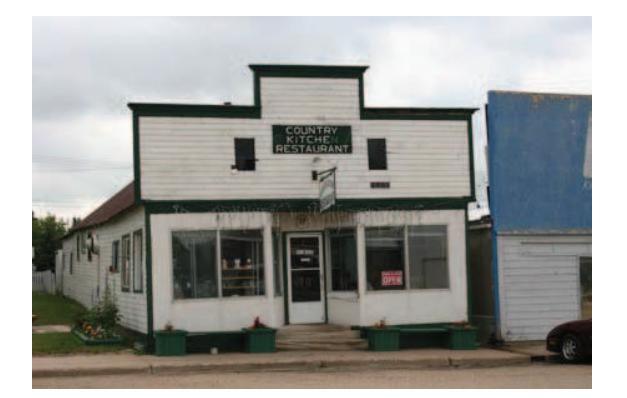
## **Country Kitchen Restaurant**

The 1934 building is a one-storey commercial building with a stepped parapet, clapboard cladding, and a recessed front entrance. It is located on Main Street (50<sup>th</sup> Street), in the village of Holden.

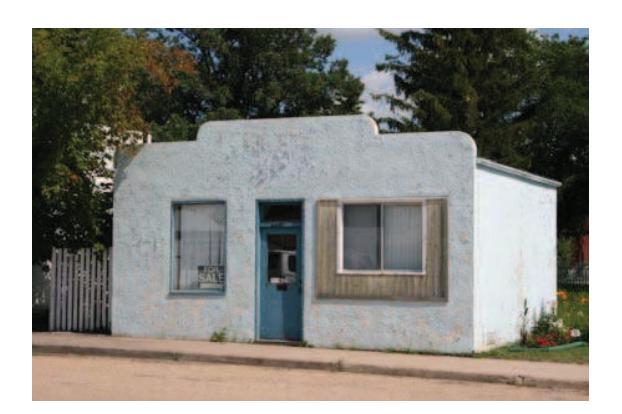
## **Old Village Office**

The 1935 Old Village Office is a small one-storey commercial building with a smooth stucco finish, a stepped parapet with rounded corners, and a central door opening. It is located on Main Street (50<sup>th</sup> Street), in the Village of Holden.

- The central door opening with a rectangular transomThe two asymmetrical window openings on the front façade
- The concrete foundation
- The pattern, style and construction of all original window and door openings

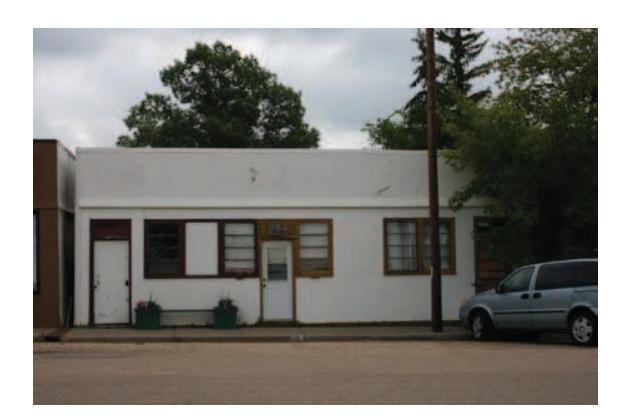
## **Old Post Office**

The 1942/63 Old Post Office is a one-storey commercial building with a rectangular parapet, a smooth stucco finish, rounded corners, three front doors and a single rain cap across the front façade. It is located on Main Street ( $50^{th}$  Street), in the village of Holden.

Integrity Criteria:	The overall integrity of this building is satisfactory.
1. Location	The location of the building has not changed.
2. Design	The design of the building has not been significantly altered, except for the replacement of the original doors.

3. Environment	The environment, or surroundings, has not changed significantly over the years.
4. Materials	The authentic materials of the building have not changed, except for the replacement of the original doors.

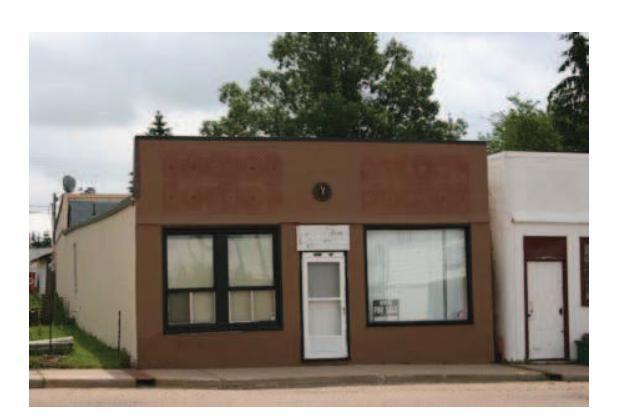
**Holden Style Shops**

The 1946 one-storey commercial Holden Style Shops building has a flat roof behind a rectangular parapet, a smooth stucco finish, and a central door between symmetrical window openings. It is located on Main Street ( $50^{\text{th}}$  Street) in the village of Holden.

- The wood window and door surrounds
- The concrete foundation
- The pattern, style and construction of all original window and door openings

3. Environment	The environment, or surroundings, has not changed significantly over the years.
4. Materials	The authentic materials of the building have not changed, except for the replacement of the original windows.

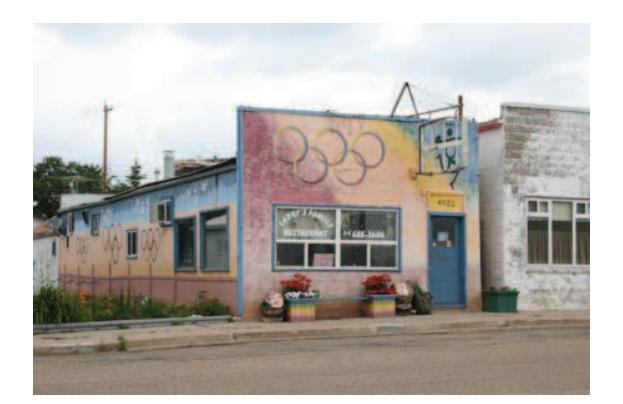
The circa 1930 Larry's Family Restaurant is a one-storey commercial building with a rectangular parapet on the front façade and a stepped parapet on the rear façade, a smooth stucco finish, and an offset main entrance with a blind transom. It is located on Main Street (50<sup>th</sup> Street) in the village of Holden.

- The shiplap siding on the north façade
- The offset front entrance with a transom
- The concrete foundation
- The pattern, style and construction of all original window and door openings

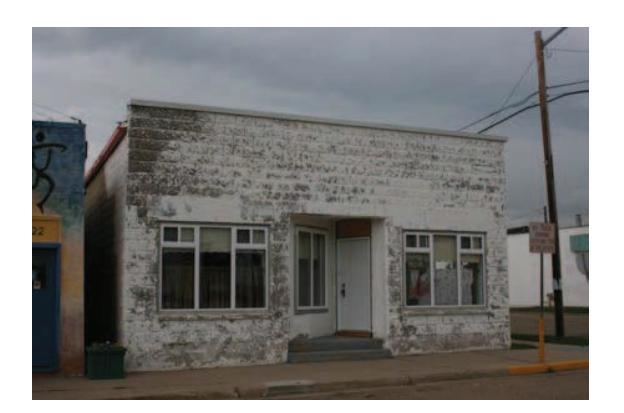
## **Chupka's General Store**

The 1951 Chupka's General Store is a one-storey commercial building with a low slope shed roof, rock faced concrete block walls, and a recessed main entrance. It is located at the corner of Main Street (50<sup>th</sup> Street) and 50<sup>th</sup> Avenue, near the Holden Cenotaph in the village of Holden.

- The concrete lintels and sills
- The concrete foundation
- The pattern, style and construction of all original window and door openings

3. Environment	The environment, or surroundings, has not changed significantly over the years.
4. Materials	The authentic materials of the building have not changed, except for the replacement of the original windows and doors.

5. Workmanship	The workmanship of the building is authentic, except for the replacement of the original windows and doors.
6. Feeling	The feeling of the building and site has not changed.

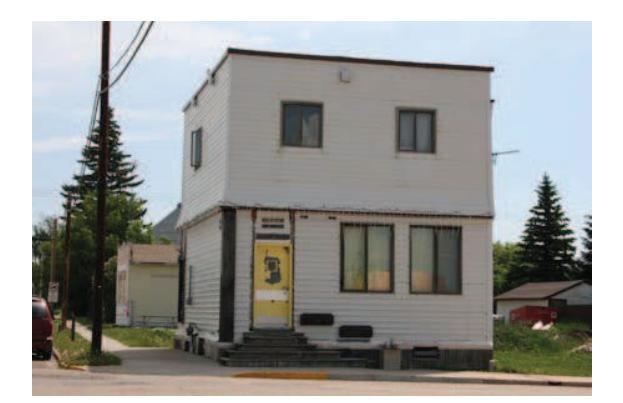
January 2011
**Royal Bank Building**

The 1912 Royal Bank Building is a two-storey former bank building with a flat roof, a flare between the first and second stories, and an offset front entrance. It is located on the corner of Main Street ( $50^{\text{th}}$  Street) and  $50^{\text{th}}$  Avenue, near the Holden Cenotaph in the village of Holden.

- The flat roof
- The rectangular parapet
- The flare between the first and second stories
- The brick chimney
- The concrete foundation
- The pattern, style and construction of all original window and door openings

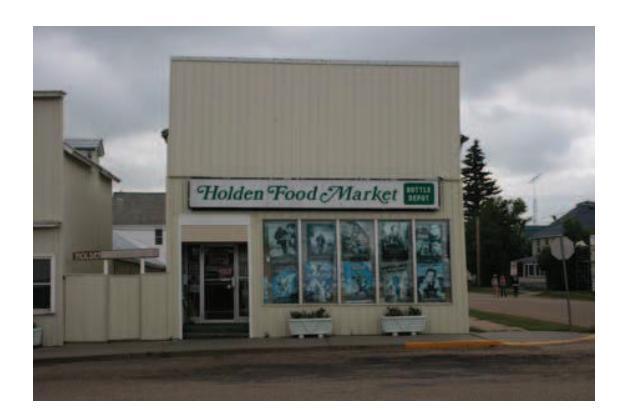
## **Holden Food Market**

The circa 1911 Holden Food Market is a one-storey commercial building with a rectangular parapet, a recessed entrance, and metal cladding. It is located at the corner of Main Street ( $50^{\text{th}}$  Street) and  $50^{\text{th}}$  Avenue, near the Holden Cenotaph in the village of Holden.

- The front-facing gable roof
- The rectangular parapet
- The concrete foundation
- The pattern, style and construction of all original window and door openings

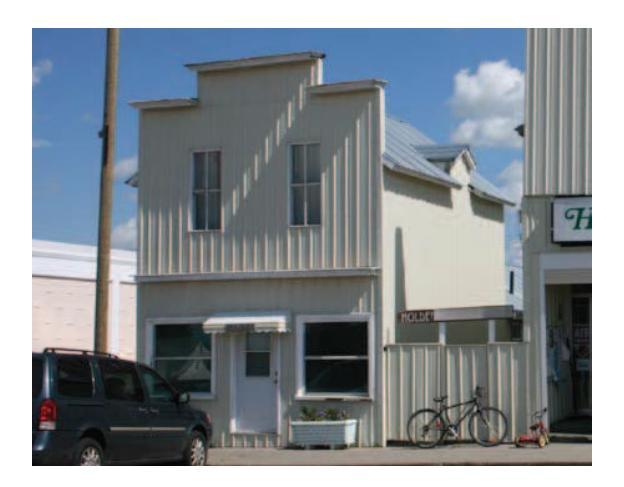
### George Maruszeczka Building

The circa 1909 one and one-half storey Maruszeczka Building has a stepped parapet, a symmetrical façade with a central main entrance, and a wooden cornice between the first and second stories. It is located on Main Street ( $50^{th}$  Street), in the village of Holden.

- The front-facing gable roof
- The stepped parapet
- The symmetrical façade
- The central main entrance
- The wooden cornice between the first and second floors
- The concrete foundation
- The pattern, style and construction of all original windows and doors, especially the two two-by-two windows on the second floor

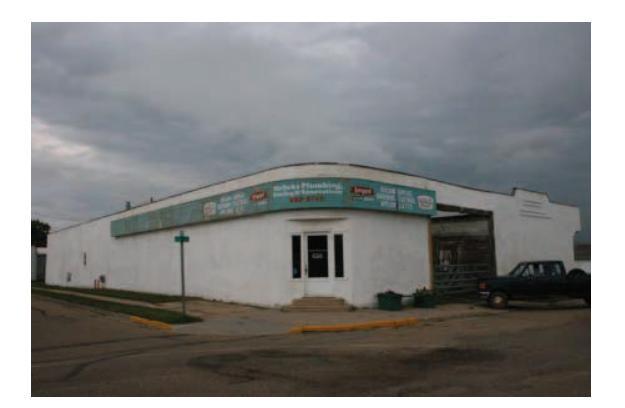
**Globe Lumber Company**

The circa 1909/1941 The Globe Lumber Company building is a one-storey commercial building with a rectangular parapet, a smooth stucco finish, rounded corners, and a corner entrance. It is located on the corner of Main Street (50<sup>th</sup> Street) and 50<sup>th</sup> Avenue, near the Holden Cenotaph in the village of Holden.

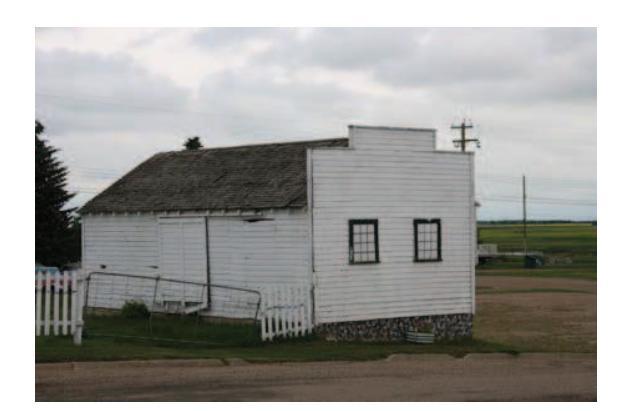
### Lumber Shed

The circa 1909 one-storey Lumber Shed has a front-facing gable roof with exposed rafters beneath the eaves, a stepped parapet, shiplap siding, and a concrete foundation. It is located on the same large lot as Malick's Repair, on Main Street (50<sup>th</sup> Street) in the village of Holden.

- Front-facing gable roof with exposed rafters beneath the eaves
- The shiplap cladding with corner boards
- The stepped parapet
- The two blind windows with flat wood surrounds on the front façade
- The sliding door on the south façade
- The concrete foundation
- The pattern, style and construction of all original window and door openings

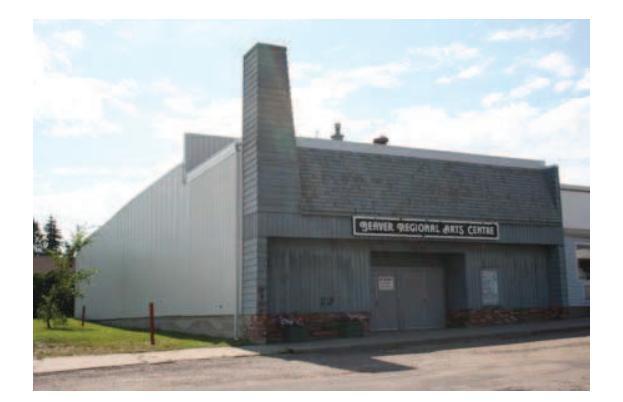
**Beaver Regional Arts Centre**

The 1954 Beaver Regional Arts Centre is a large one-storey commercial building with a rectangular parapet, wood shingle and clapboard siding on the front façade, and a large, prominent chimney on the north west corner. It is located at the north end of Main Street (50<sup>th</sup> Street), in the village of Holden.
